REPAIR OF STONE MASONRY ARCH BRIDGES

Daniel V. Oliveira^{*} and Paulo B. Lourenço[†]

Key words: stone masonry, repair measures, architectural heritage

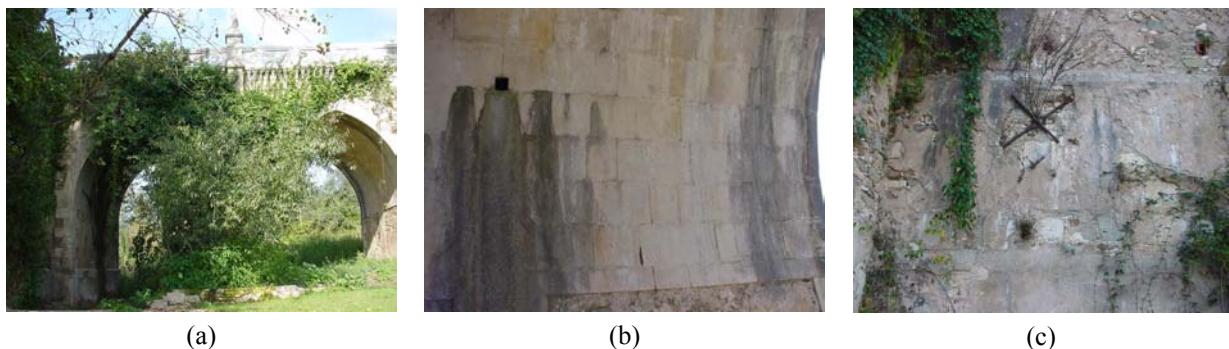
Due to its uncertain safety conditions and taking into account its heritage value, a survey of the Boutaca bridge was requested². The detailed inspection carried out allowed to detect damage in several areas. The absence of periodic maintenance works promoted the growth of vegetation, as well as the lost of plaster and painting in large areas of the bridge. The deficient drainage system of the pavement caused the occurrence of humidity and biological colonization, detected in the visual inspection, see Figure 2. It was also found some minor longitudinal cracking at the intrados of some arches, as well as cracking in the buttresses, due to lateral forces generated through the fill and caused by dead and live loads.

The survey detected four metallic tie rods endowed with anchorages on one side of the bridge (downstream), to bind the walls. The anchorages were much deteriorated, with visible corrosion, and rather deformed being not possible to detected similar anchorages on the other side (upstream). The excessive deformation of the anchorages, as well as cracking in buttresses seem to indicate that masonry walls suffered outward movements after the placement of the tie rods and that buttresses may be overload.

Figure 2: Main damage: (a) vegetation; (b) humidity; (c) corroded anchorage (downstream view).

Taking into account the rehabilitation and the protection of the bridge, a set of remedial measures were recommended³, in accordance with the principles that guide interventions in the architectural heritage. To prevent the outward movement of the masonry walls and to lighten the load in the buttresses, it was proposed the execution of a set of horizontal anchors across the full width of the road, endowed with patress plates, which have been designed to be aesthetically attractive. Four vertically aligned tie rods between each two buttresses were adopted, as illustrated in Figure 3. For each anchor, a hole is drilled and a stainless steel rod with 39 mm diameter is placed inside. At the ends, two cylindrical stainless steel patress plates are tightened up. A slight force is applied to the tie rods by means of a dynamometric wrench, in order to put them in tension.

In order to reduce the lateral pressure on the walls and the appearance of humidity at the intrados of arches it was proposed to perform the waterproofing of the pavement and the reconstruction of all the drainage system. Also, the cleaning and removal of infesting vegetation in the bridge should be periodically carried out. The missing plaster and painting should be replaced, using materials as similar as possible to those used in the construction.

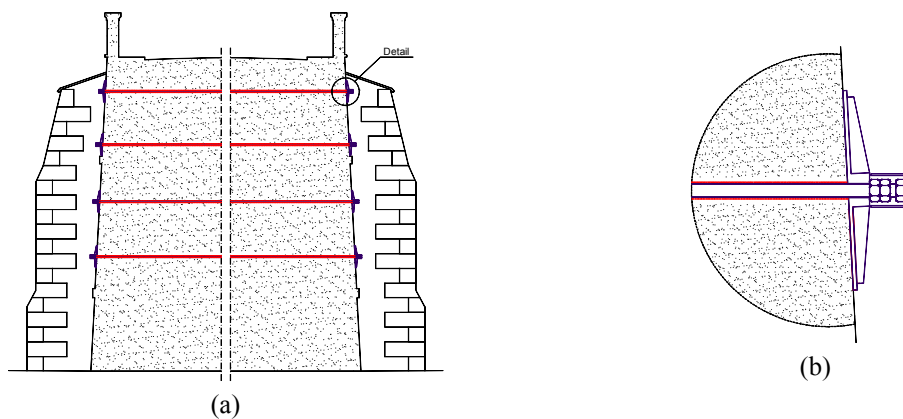
Figure 3: Strengthening of the masonry walls: (a) general view; (b) detail of the patress plate.

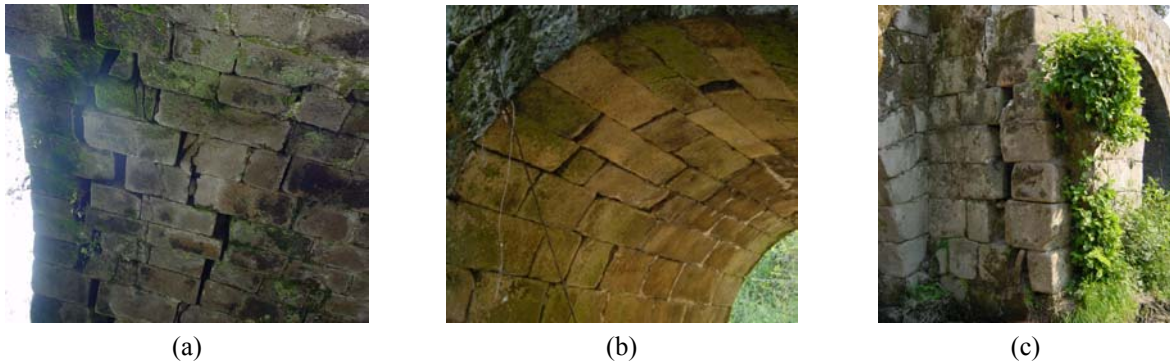
The survey⁴ has showed that the structure presents a pronounced damage state. Both the left arch (A1) and the flood arch (A4) present extensive longitudinal cracking, clearly visible at the intrados, see Figure 5. The right pier is very damaged, where some stone blocks are cracked and a foundation stone is missing. The vegetation, spread all over the bridge, caused severe damage to the right cutwater. The spandrel walls were subjected to lateral movement and are clearly out of plumb. The general damage pattern observed was originated by the lack of maintenance in conjunction with increasingly heavy loads.

Figure 5: Relevant damage: (a) cracks in the left arch; (b) cracks in the flood arch; (c) cracks in the right cutwater.

justify the observed longitudinal cracking at the intrados of the arches. Both the detailed visual inspection and the numerical analysis pointed out that the strengthening of the bridge was necessary, namely to counteract the outward movement of the spandrel walls, to prevent their failure and to stop the progression of the longitudinal cracking along the arches, in order to re-establish the safety conditions of the bridge.

Given the historical significance of Donim bridge, the design of any strengthening measure was necessarily conditioned by the fulfilment of modern principles related to structural intervention. Therefore, the remedial measures designed and proposed to restore the safety of the bridge comprehend the structural strengthening of the arch A1, the flood arch and the cutwater of the right pier⁶.

The high level of damage found in the right cutwater, with several stones cracked and out of their original places, will be repaired by the dismantling of the most deteriorated areas. The rebuilding will be carried out using the same stones, previously numbered, or when not able to be used, with similar stones from the region. During the rebuilding, stones in a same course will be connected to each other by means of stainless steel cramps, at every three courses. The link between two consecutive courses is achieved through the use of vertical stainless steel latches. The repair of the cutwater still includes the replacement of the missing foundation stone block.

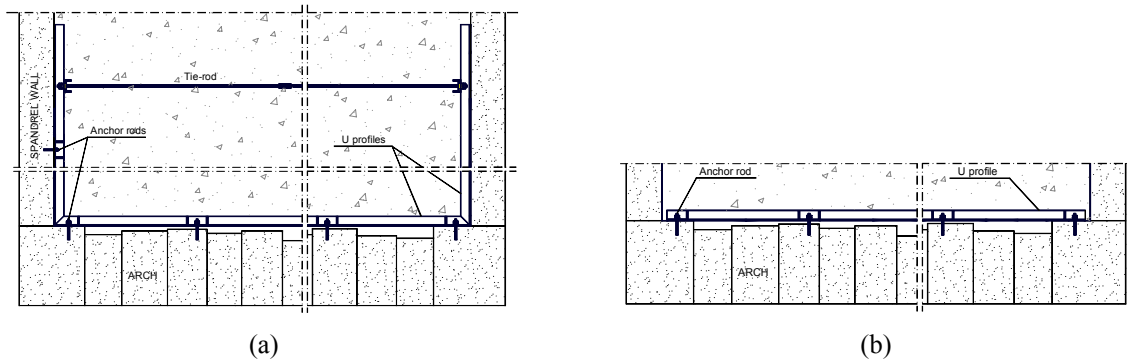
Figure 6: Strengthening of the arch A1 with U profiles: (a) in general; (b) close to the crown.

To reduce the enormous longitudinal cracking in the intrados of arch A1 (crack width greater than 8 cm) and return joint's thickness to its original width, the infill above the arch A1 will be removed and the voussoirs will be pushed in by means of rope-stretchers placed along the intrados of the arch, for which the arch must be previously propped along its entire span. The adopted strengthening comprises the fixing of six stainless steel U profiles to the extrados of the arch and to both spandrel walls, by means of anchor rods, as illustrated in Figure 6. A stainless steel tie rod, with a diameter of 16 mm, placed at the top of the vertical profiles and tightened by means of a dynamometric wrench binds the spandrel walls together and reduces considerably the bending of the profile. Close to the crown, the proximity of the pavement allowed only the use of a U profile clamped to the arch with anchor rods. After the completion of these works, the infill is put back in its place and the prop can be finally removed.

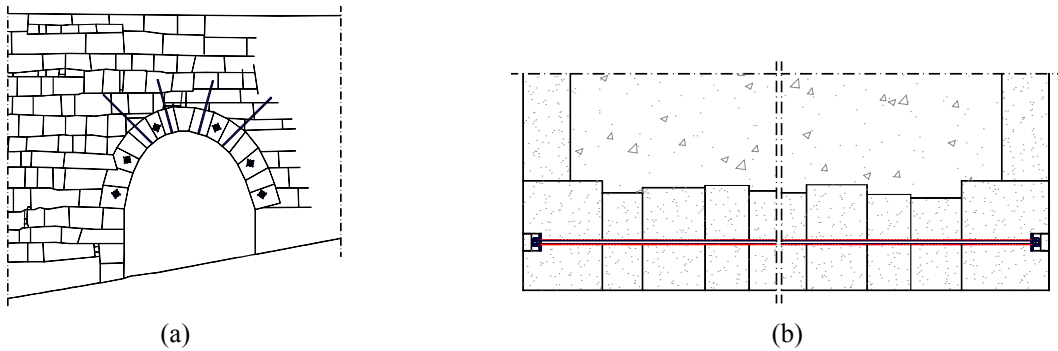
The cracking pattern observed in the flood arch has showed fewer degree of damage, with maximum crack width lower than 4 cm. Here, the objective was not to return the arch to its original geometry but to prevent any further spreading of the arch and to assure its stability. Thus, it was proposed to use six horizontal anchors across the full width of the bridge, endowed with cylindrical anchorage plates at each side of the arch, see Figure 7.

Figure 7: Strengthening of the flood arch: (a) adopted anchor scheme; (b) horizontal anchors.

In each anchor, after drilling an oversized hole using a rotating cutting device, a stainless steel rod with 16 mm of diameter involved by a sleeve, is placed in the hole and subsequently grouted with a cement solution, injected under low pressure between the rod and the sleeve. The use of the sleeve increases the efficiency of the anchor system since it inflates, preventing the injected grout to be lost in voids within the structure, or flee through cracks.

No tension is applied to the rods other than a tightening force resulting from their adjustment using a dynamometric wrench. Following grouting of the anchors, the hole is made good with a slip taken from the cores.

For the connection between the arch and spandrel walls a similar solution was developed. Four stitching anchors in each side of the arch (see Figure 7a), ranging between 1200 mm and 1500 mm length, were used with the purpose of linking the spandrel walls to the external voussoirs.
